#### IN THE UNITED STATES DISTRICT COURT FOR THE MIDDLE DISTRICT OF PENNSYLVANIA

NO. 1:20-CV-00764

#### **AMENDED COMPLAINT**

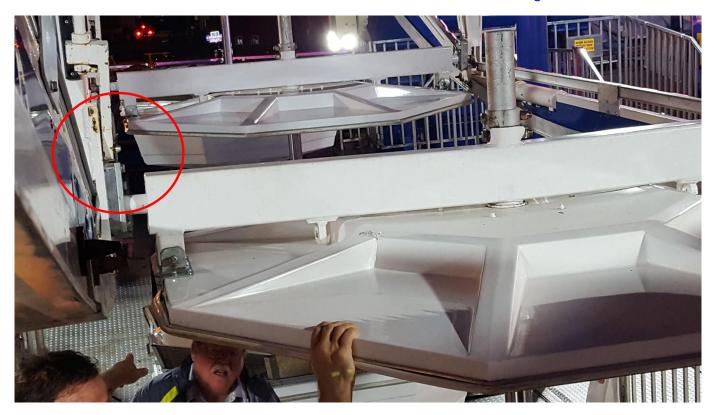
• The tie rod pins are located away from patrons and are located next to the bearing block for the T bar to which the gondolas are mounted. There is very little room between a Hairpin and the bearing block. If the pin rotates, a sprung Hairpin could contact the bearing block. See **Fig. 5** and **Fig. 6**.

Fig. 5 – Tie rod pins location away from patrons and are very close proximity to bearing block.

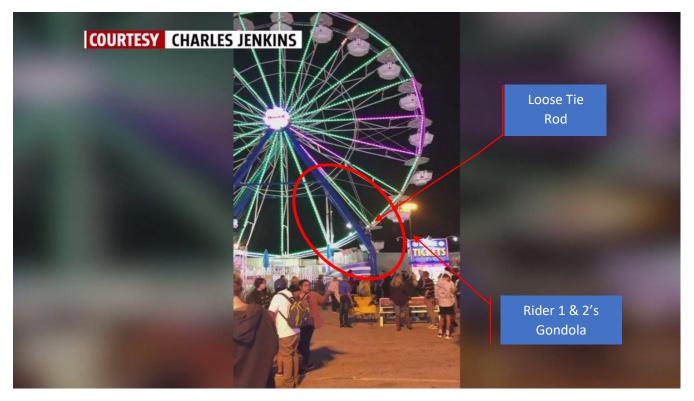
• Local media assisted by providing a bystander's video of the ride after the accident. Please note the captured still picture from the video details the loose tie rod that caused Gondola 1 to tip. See Fig. 7.

Fig. 7 – The Wheel shortly after the accident, note the loose tie rod

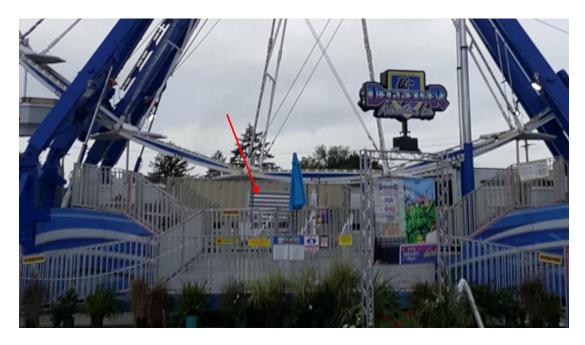
• The generator power plant for the midway was located behind the Wheel. The noise from the power plant may have been enough to hinder communication between the operators, assistants and patrons. Riders 1 & 2 emphasized that they attempted to shout to the operators prior to the accident. The power plant was in operation during the investigation and the noise was as described by Riders 1 & 2 and made it difficult to communicate during the investigation. See **Fig. 9**.

**Fig. 9** – Notes the location and proximity of the power plant to the Wheel. The slats shown are to let air into the power plant but also do little to muffle the noise of the power plant
